BROOME COUNTY FIREFIGHTERS' ASSOCIATION

Port Dickinson Handles Commercial Building Fire With a Special Hazard

By Nicholas Griswold

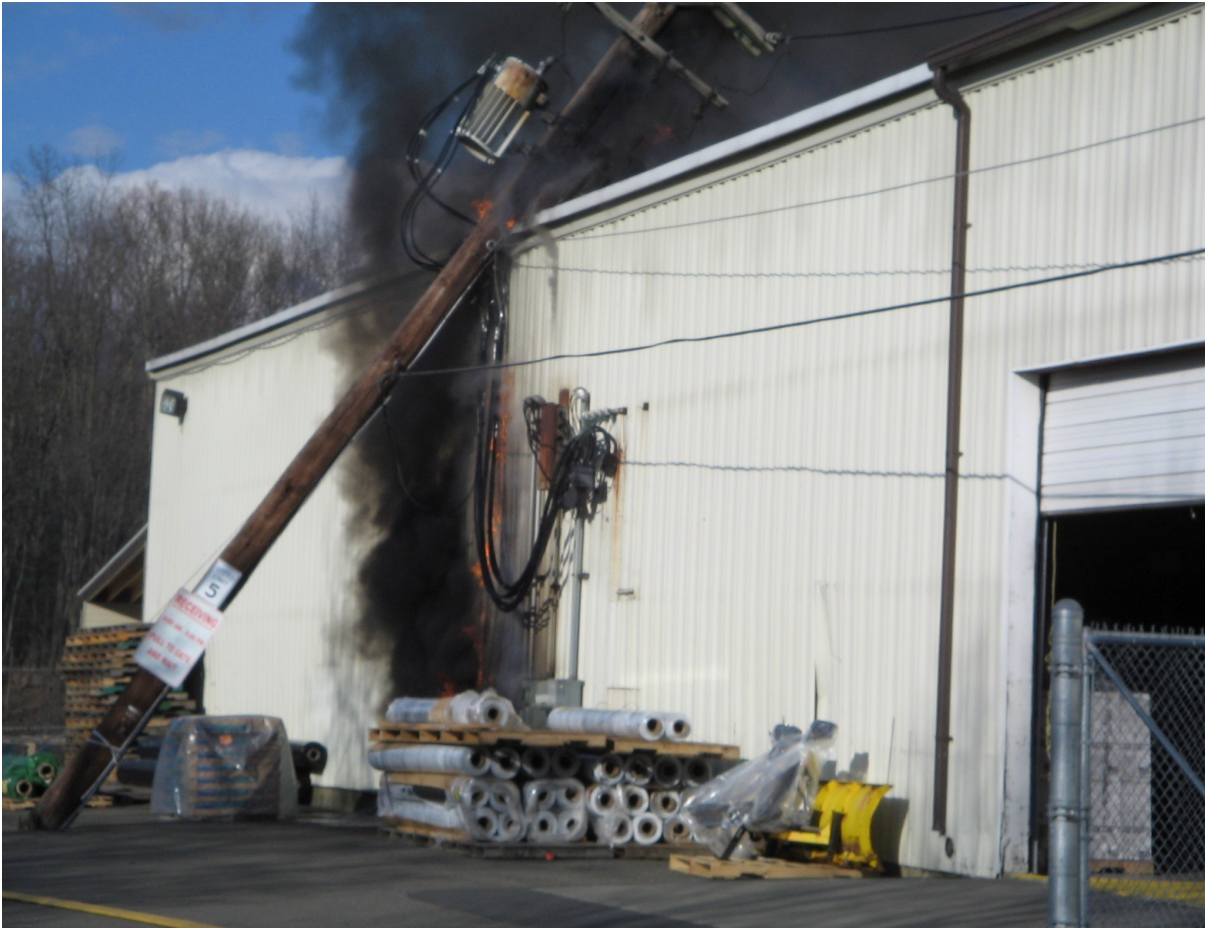
D. L. Shelley Photo- Visible fire on the outside of the building as pumper tanker 35 lays a supply line.

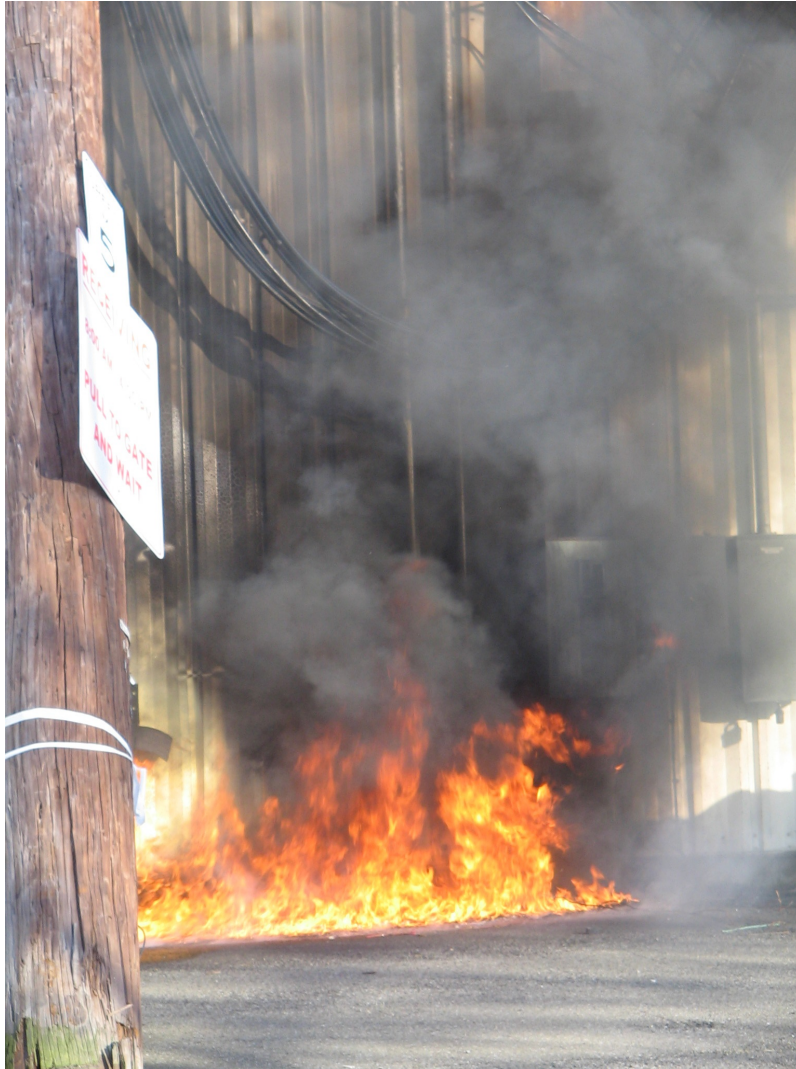
D. L. Shelley Photo- Oil that has run down the side of the building onto the ground catches fire from the arcing.

Once the fire was extinguished crews began overhauling the roof area and checking for extension inside the building. Finding no further extension mutual aid companies were allowed to begin clearing from the scene. It was determined that high winds had blown the utility pole over and onto the building. This caused the oil inside several large transformers at the top of the pole to spill out onto the roof and run down the side of the building. The arcing from the power lines then set the oil

on fire which spread into structural members of the building.

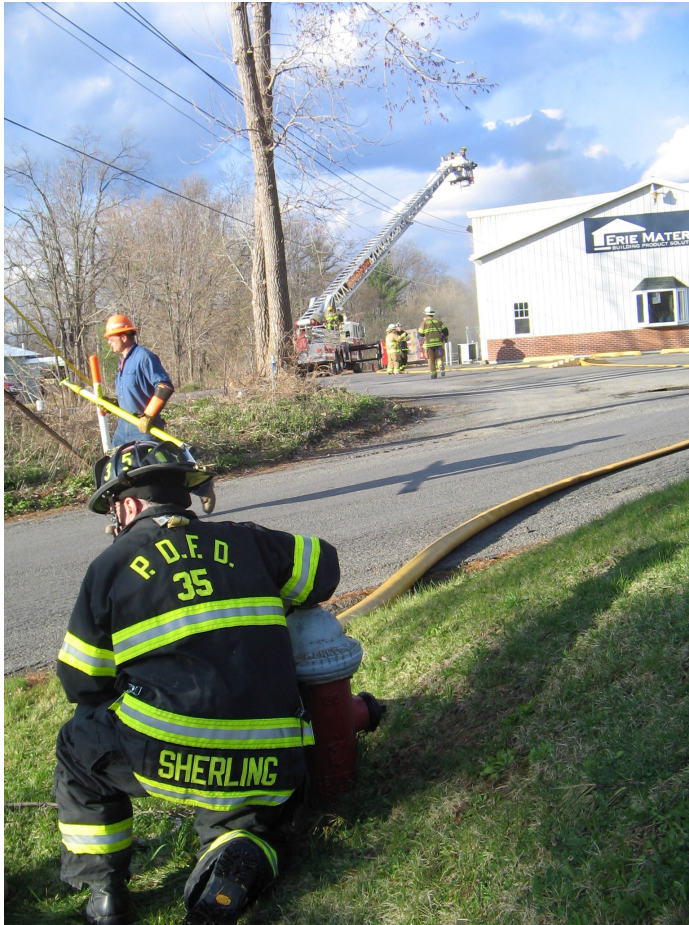
D. L. Shelley Photo- Water supply is established
NYSEG works to get power off in the area.

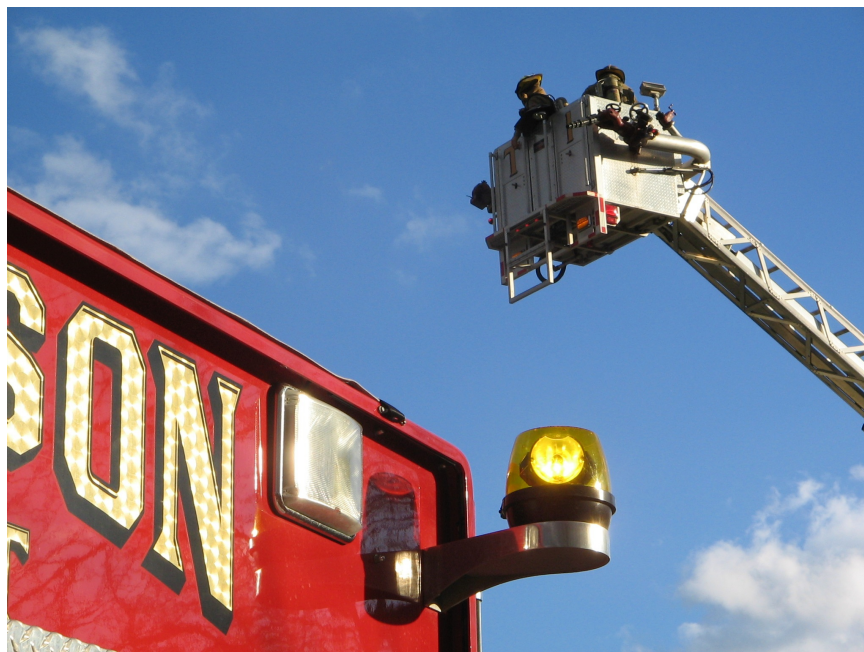
D. L. Shelley Photo - The crew of Tower 21 awaits further orders
as crews check for extension

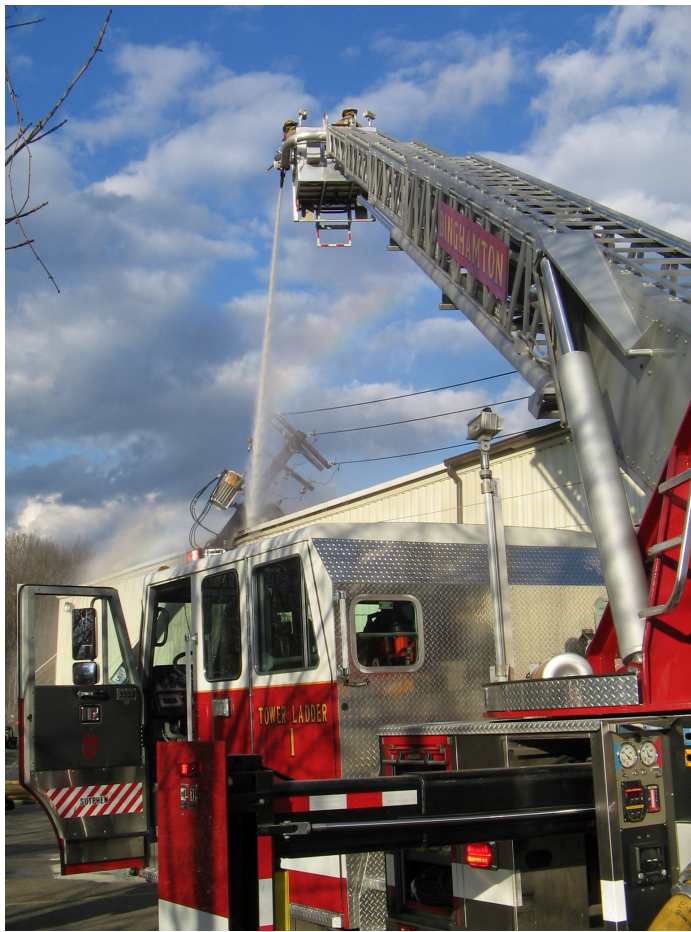
D. L. Shelley Photo - Binghamton Tower 21 begins flowing water to extinguish the fire.

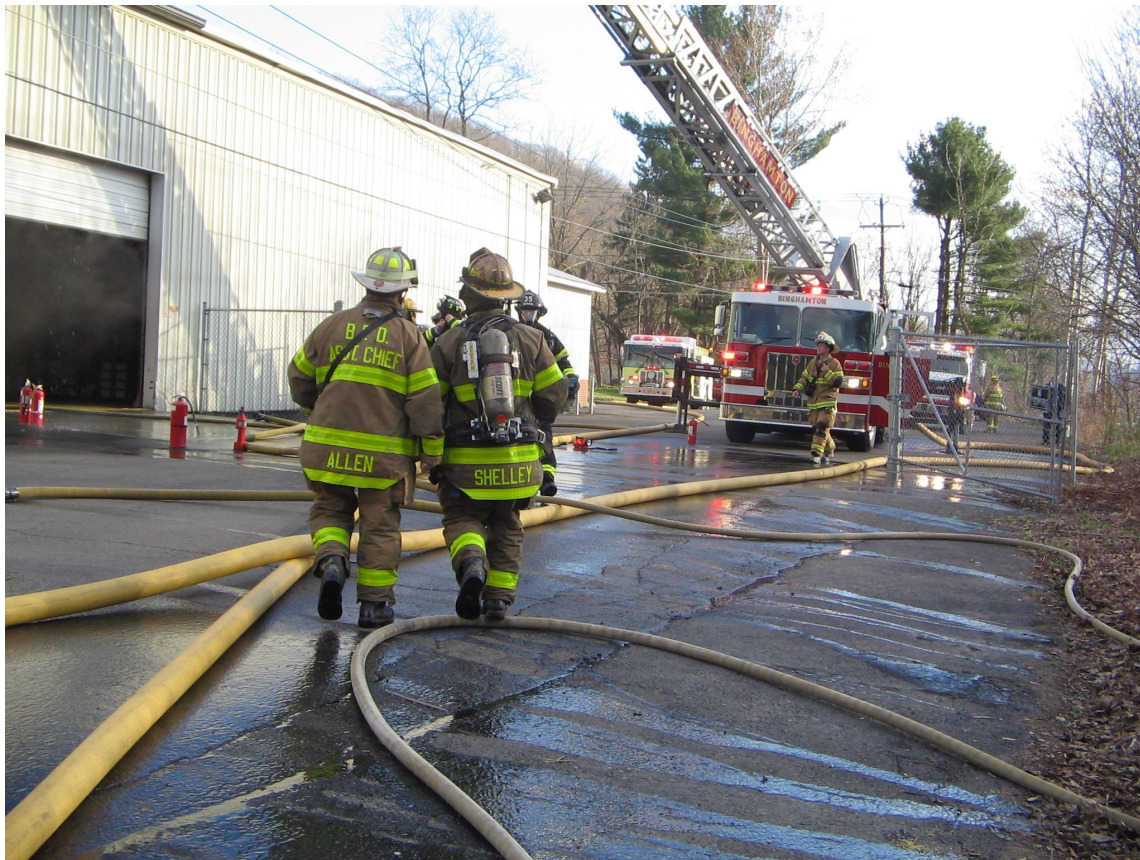
D. L. Shelley Photo- Crews from Binghamton monitor Towers ops as a crew from Port Dickinson is ready to enter the building. Smoke can still be seen coming from the garage with Tower 21 in the background
