Power Saw Blade Failure

- What: Partner K-12 power saw blade failure (Target EH series 14" hand-Held High Speed DRY/WET cutting Diamond Blade)
- When: Saturday 25 APR 09 (approx. 1430)
- Where: 506 ECES/CEF, Kirkuk Regional Air Base, Iraq
- **Background:** Personnel were cutting wood (fallen dead trees) using chain saw and Partner K-12 (blade *identified above*)

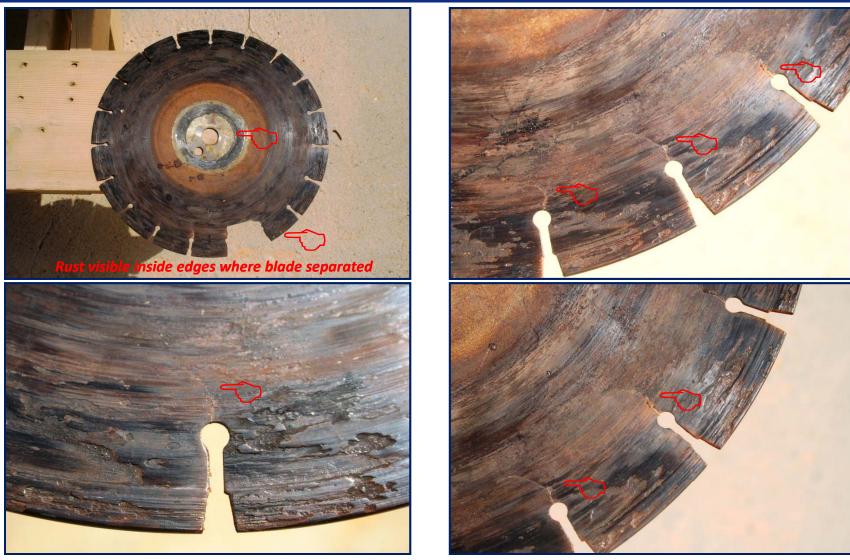
The Blade

- Inspection of the blade revealed multiple cracks in the blade
- Rust was visible on inside edges where blade failed/separated indicating cracks were present for sometime prior to the cutting operation
- Further inspection revealed other blades with same cracks
- Blades were rusty, warning labels completely worn off
- The warning label was worn off from the affected blade and several others

- All personnel in AOR and CONUS verify adequate inspection checklists are available AND UTILIZED for all power equipment
- Conduct spot-checks to verify effective inspections are carried out
- Refresher training to insure personnel use the right tool (and blade) for the right job
- Identify, report, and replace potentially defective equipment ASAP
- Remove saw blades from service if they:
 - Do not have a readily available legible and understandable set of instructions and warning cautions
 - Appear unserviceable or environmentally compromised (rust, worn) or are cracked
 - Do not match saw manufacturer recommended RPM and pairing
- Ensure personnel do not become complacent in their daily inspection of vehicles & equipment
